Manhole Inspection Summary

Manhole # S13GG1002MH

Insp Date: **11/11/08 9:05 AM**

Location Address: **4217 PIMLICO RD** Cross Street: **QUANTICO AVE**

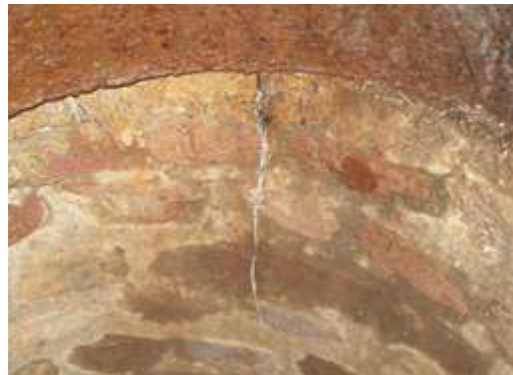
Defect 2

Condition: ☐ Sound ☒ **Cracked** ☐ Root Intrusion ☐ Loose Brick ☐ Deteriorated

CRACKED CORBEL

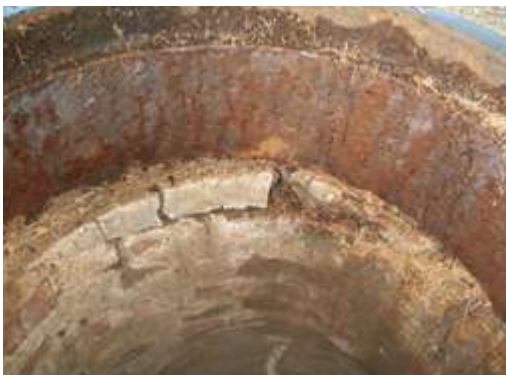
Defect 1

Condition: ☐ Sound ☒ **Cracked** ☒ **Root Intrusion** ☐ Loose Brick ☐ Deteriorated

CRACKED AND ROOT INTRUSION ON CHIMNEY

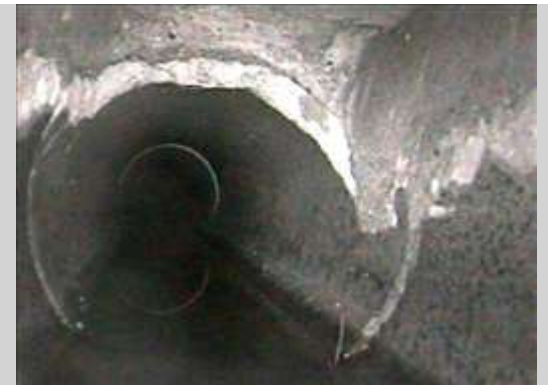
6 O'Clock Inflow

Pipe Height: (in.) Direct
Pipe Material: **Clay** ☐ Pipe Lined
Invert Depth: **8.87** (ft.) Flow Characteristics: **Slow**
Deposits: ☒ None ☐ Mud ☐ Sludge ☐ Debris ☐ Grease
Silt Depth: (in.) Deposits Extent:
Infiltration: **None** Pipe Seal Cond: **Broken**
